**Flood Control Project Maintenance
Levee Inspections**

Fall 2016 Levee Maintenance Deficiency Summary Report

**Flood Control Project Maintenance
Levee Inspections**
LMA District Cover Sheet
Fall 2016 Levee Inspection Results

Marysville Levee Commission

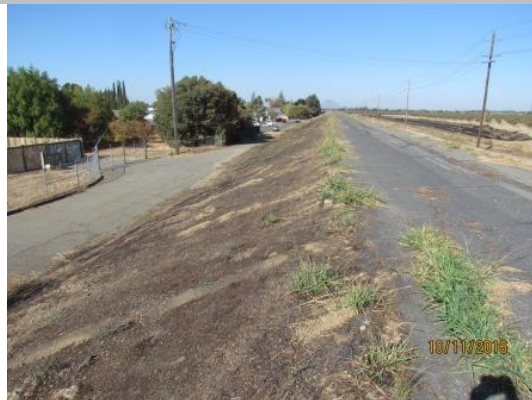
Photo 1 of 1 : FA_2016_NA0004_104_1_20161012_00015.jpg

View of well maintained vegetation, Landside looking downstream. Fall 2016.

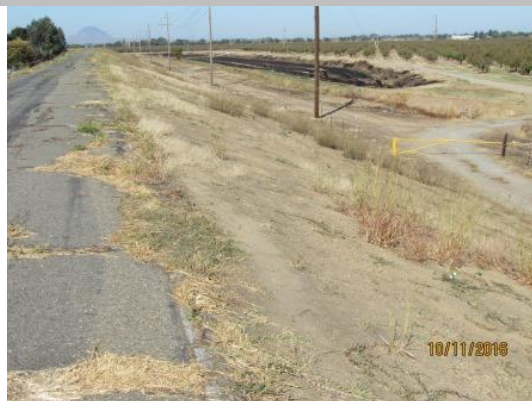
Photo 1 of 1 : FA_2016_NA0004_104_11_20161012_00016.jpg

View of well maintained annual vegetation, waterside looking downstream. Fall 2016.

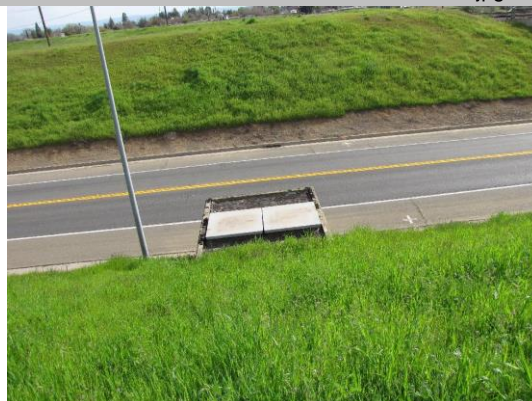
Photo 1 of 2 : UCIP_FA_2016_40931_69758.jpg

LM Start	0.96	Rating **	M	Issue No.	37
LM End	0.96	Issue Type +	En	Location *	WS
Category	Supplemental			GPS Latitude/Longitude	
				Start	End
Item	DWR UCIP Field Study			39.158946 °	39.158946 °
				-121.589930 °	-121.589930 °
DWR ID					
Comment Code					
Inspector Comment					
FS_ID:40931 DS_ID:19100 EP_NO: 14518 Repair Type: Non-Urgent Crossing Status: Indicator Found UCIP Comments: Recommend having owner removing tall grass along slopes to properly inspect signs of pipe failure. FIELD_STRUCT_DESC: 1 of 2: 10-inch steel pipe through levee, 4.0 feet below crown. Flap gate on waterward end. Concrete vault on waterward shoulder. Metal meter box on the landward shoulder. Pump placed on concrete footings at toe of landward slope. Drainage for underpass. Pipes approx. 2.5-feet apart. (Permit No. 14518-1987). FS Date: 3/14/2013

View of landward side.

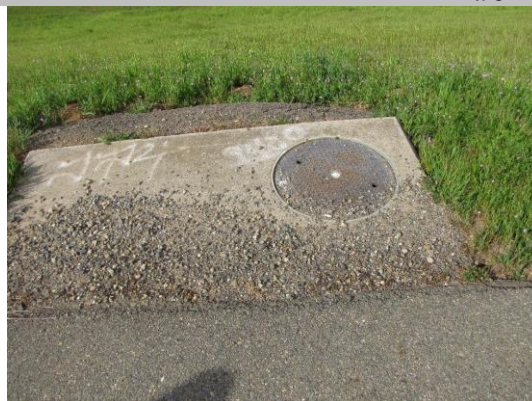
Photo 2 of 2 : UCIP_FA_2016_40931_69757.jpg

LM Start	0.96	Rating **	M	Issue No.	37 (cont)	
LM End	0.96	Issue Type +	En	Location *	WS	
Category	Supplemental			GPS Latitude/Longitude		
				Start	End	
Item	DWR UCIP Field Study			39.158946 °	39.158946 °	
				-121.589930 °	-121.589930 °	
DWR ID						
Comment Code						
Inspector Comment						
FS_ID:40931						
DS_ID:19100						
EP_NO: 14518						
Repair Type: Non-Urgent						
Crossing Status: Indicator Found						
UCIP Comments: Recommend having owner removing tall grass along slopes to properly inspect signs of pipe failure.						
FIELD_STRUCT_DESC: 1 of 2: 10-inch steel pipe through levee, 4.0 feet below crown. Flap gate on waterward end. Concrete vault on waterward shoulder. Metal meter box on the landward shoulder. Pump placed on concrete footings at toe of landward slope. Drainage for underpass. Pipes approx. 2.5-feet apart. (Permit No. 14518-1987).						
FS Date: 3/14/2013

Concrete vault on waterward shoulder with manhole.

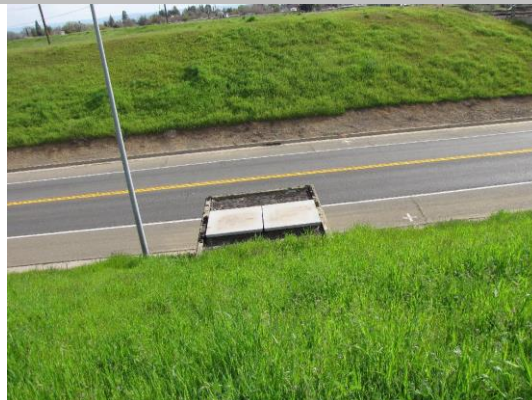
Photo 1 of 2 : UCIP_FA_2016_40933_69762.jpg

LM Start	0.96	Rating **	M	Issue No.	38
LM End	0.96	Issue Type +	En	Location *	WS
Category	Supplemental			GPS Latitude/Longitude	
				Start	End
Item	DWR UCIP Field Study			39.158951 °	39.158951 °
				-121.589929 °	-121.589929 °
DWR ID					
Comment Code					
Inspector Comment					
FS_ID:40933 DS_ID:19093 EP_NO: 14518 Repair Type: Non-Urgent Crossing Status: Indicator Found UCIP Comments: Recommend having owner removing tall grass along slopes to properly inspect signs of pipe failure. FIELD_STRUCT_DESC: 2 of 2: 10-inch steel pipe through levee, 4.0 feet below crown. Flap gate on waterward end. Concrete vault on waterward shoulder. Metal meter box on the landward shoulder. Pump placed on concrete footings at toe of landward slope. Drainage for underpass. Pipes approx. 2.5-feet apart. (Permit No. 14518-1987). FS Date: 3/14/2013

View of pump concrete building located on landward side.

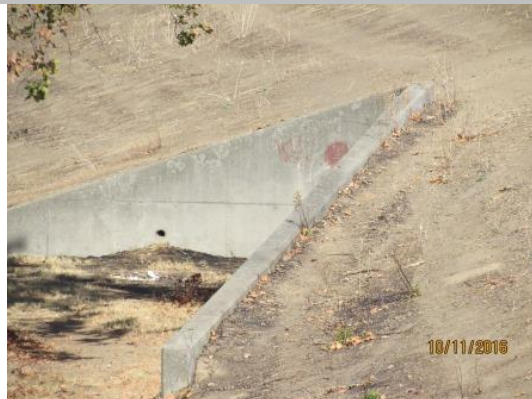
Photo 1 of 1 : FA_2016_NA0004_104_17_20161012_00018.jpg

View of headwall for pipe, landside looking upstream. This is permitted under Permit #14518. Fall 2016.

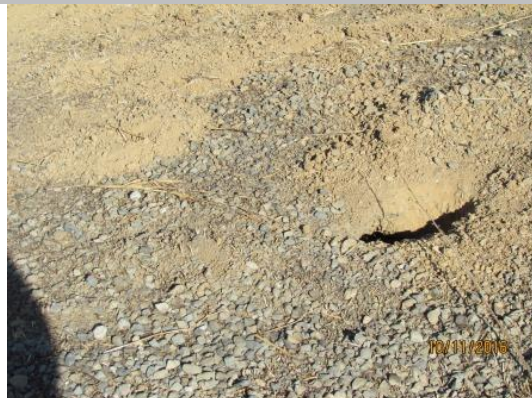
Photo 1 of 1 : FA_2016_NA0004_104_16_20161012_00020.jpg

View of rodent holes where squirrels are active. Fall 2016.

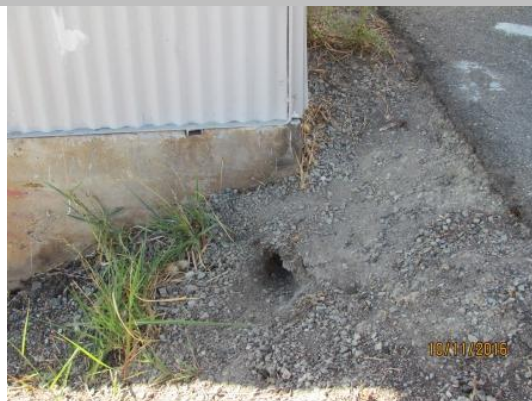
Photo 1 of 1 : FA_2016_NA0004_104_15_20161012_00021.jpg

Rodent holes where squirrels are active, landside. Fall 2016.

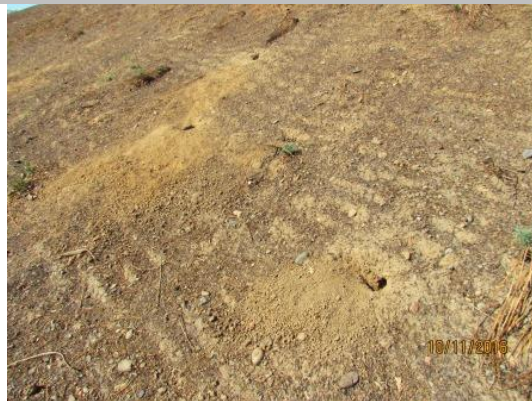
Photo 1 of 1 : FA_2016_NA0004_104_14_20161012_00022.jpg

LM Start	1.87	Rating **	M	Issue No.	14
LM End	1.87	Issue Type +	Ma	Location *	LS
Category	Earthen Levee			GPS Latitude/Longitude	
				Start	End
Item	Animal Control			39.164541 °	39.164541 °
				-121.584044 °	-121.584044 °
DWR ID	DWR_NA0004_01_f_2016_14				
Comment Code					
A1 : Exterminate rodents and backfill and compact or grout burrows.					
Inspector Comment					
Rodent holes where squirrels are active. Fall 2016.

View of landside rodent holes where squirrels are active, looking downstream. Fall 2016.

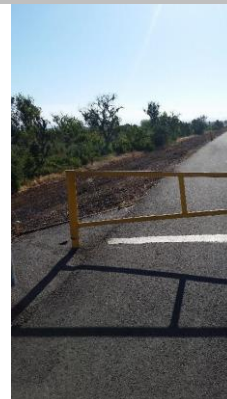
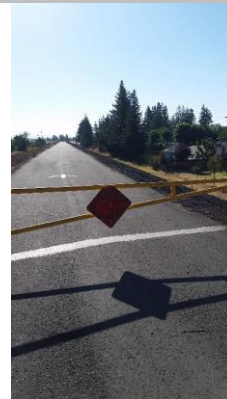
FS_ID:49953
DS_ID:25467
EP_NO: N/A
Repair Type: Urgent
Crossing Status: Not Found
UCIP Comments: 6/29/2016 Per Frank Miller, LMA Contact, the USACE has identified an 8-inch gas line through levee. Unable to confirm owner, permit, or depth of crossing. (DWR UCIP - omagana)
FIELD_STRUCT_DESC: 8-inch gas line of unknown material through the levee at an unknown depth.
FS Date: 6/29/2016

View of levee crown where crossing goes through levee--no markers visible, photo 1 of 2.

View of levee crown where crossing goes through levee--no markers visible, photo 2 of 2.

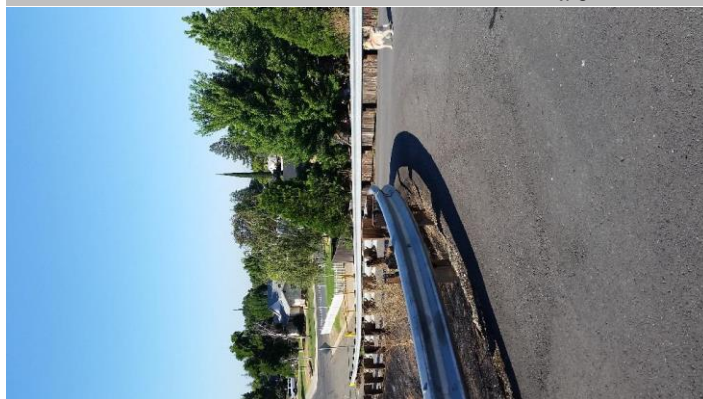
Photo 1 of 2 : UCIP_FA_2016_49954_75429.jpg

FS_ID:49954
DS_ID:19112
EP_NO: 2279
Repair Type: Non-Urgent
Crossing Status: Found
UCIP Comments: 6/30/2016 Coordinating with the USACE to obtain record drawings of the utilities identified during Slurry Wall construction. (DWR UCIP - omagana)6/29/2016 *ABANDONED* pipe confirmed during USACE Project of Slurry Wall along Unit 1. Project completed approximately 5 years ago. Frank Miller, recommended contacting Art (USACE contact) to obtain project records for the slurry wall work completed in this area. (DWR UCIP - omagana)1/1/2014 Frank Miller Superintendent Marysville Levee Commission:To whom it may concern, Marysville Levee Commission is in process of drafting letter to PG&E concerning line status, wether active/or non-active as well as exact cordinates. (LMA Superintendent - fmiller)3/14/2013 No markers found. Need to contact owner to determine status of crossing. (DWR UCIP - omagana)
FIELD_STRUCT_DESC: *ABANDONED* 0.75-inch steel concrete encased gas line through the levee, 5.0 feet below the crown. Steel plate at center of levee (6-foot by 6-foot #8 Ga.), surrounds concrete encasement. (Permit No. 2279, 1958 - Pacific Gas and Electric Co. [PG&E]). [Additional Reference(s): DWR Levee Log, 1993 and 2005]

View of levee crown.

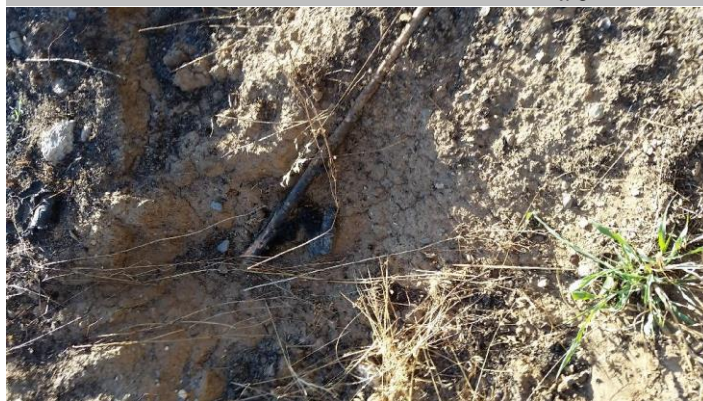
Photo 2 of 2 : UCIP_FA_2016_49954_75430.jpg

Line visible on LS.

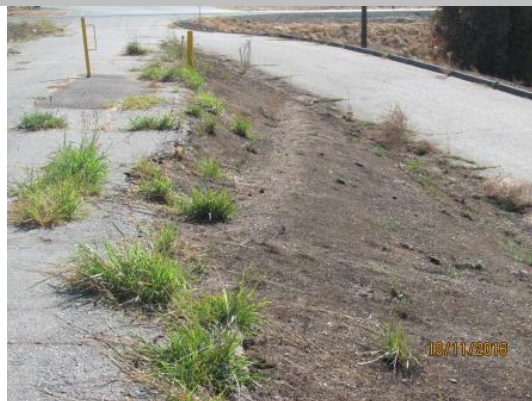
Photo 1 of 1 : FA_2016_NA0004_104_12_20161012_00023.jpg

LM Start	3.15	Rating **	A	Issue No.	12
LM End	3.15	Issue Type +	Ma	Location *	LS
Category	Earthen Levee			GPS Latitude/Longitude	
				Start	End
Item	Slope Stability			39.164068 °	39.164068 °
				-121.560859 °	-121.560859 °
DWR ID	DWR_NA0004_01_f_2016_12				
Comment Code					
S2 : Repair the levee slope damaged by foot traffic and prevent access where possible.					
Inspector Comment					
Foot path has been cut into levee slope, no sign of slope instability. Fall 2016.

View of landside looking upstream where foot path has been cut into levee slope, no sign of slope instability. Fall 2016.

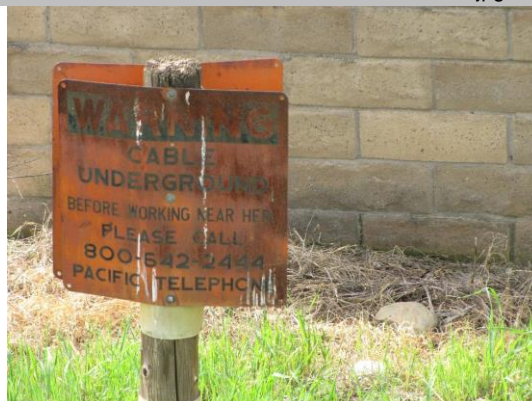
Photo 1 of 2 : UCIP_FA_2016_40935_69766.jpg

LM Start	3.19	Rating **	M	Issue No.	39
LM End	3.19	Issue Type +	En	Location *	LS
Category	Supplemental			GPS Latitude/Longitude	
				Start	End
Item	DWR UCIP Field Study			39.163888 °	39.163888 °
				-121.560262 °	-121.560262 °
DWR ID					
Comment Code					
Inspector Comment					
FS_ID:40935					
DS_ID:19115					
EP_NO: 12878					
Repair Type: Non-Urgent					
Crossing Status: Indicator Found					
UCIP Comments: Need to contact owner to determine additional information about crossing and alignment.					
FIELD_STRUCT_DESC: 24-inch steel pipe encasing 4-inch PVC communications extension through the levee, annular gap grouted, 8 feet below levee crown. Cutoff wall (12x12x20-inch) around extension from levee slopes. (Permit No. 12878-1980).					
FS Date: 3/14/2013

Marker on landward side.

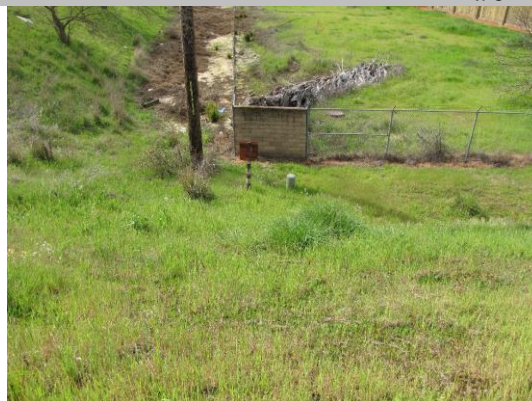
Photo 2 of 2 : UCIP_FA_2016_40935_69765.jpg

LM Start	3.19	Rating **	M	Issue No.	39 (cont)	
LM End	3.19	Issue Type +	En	Location *	LS	
Category	Supplemental			GPS Latitude/Longitude		
				Start	End	
Item	DWR UCIP Field Study			39.163888 °	39.163888 °	
				-121.560262 °	-121.560262 °	
DWR ID						
Comment Code						
Inspector Comment						
FS_ID:40935						
DS_ID:19115						
EP_NO: 12878						
Repair Type: Non-Urgent						
Crossing Status: Indicator Found						
UCIP Comments: Need to contact owner to determine additional information about crossing and alignment.						
FIELD_STRUCT_DESC: 24-inch steel pipe encasing 4-inch PVC communications extension through the levee, annular gap grouted, 8 feet below levee crown. Cutoff wall (12x12x20-inch) around extension from levee slopes. (Permit No. 12878-1980).						
FS Date: 3/14/2013

View of landward side.

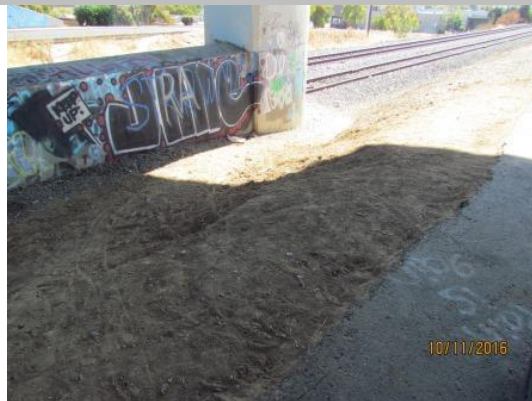
Photo 1 of 1 : FA_2016_NA0004_105_4_20161013_00016.jpg

LM Start	0.32	Rating **	M	Issue No.	4
LM End	0.32	Issue Type +	Ma	Location *	LS
Category	Earthen Levee			GPS Latitude/Longitude	
				Start	End
Item	Slope Stability			39.144840 °	39.144840 °
				-121.600559 °	-121.600559 °
DWR ID	DWR_NA0004_02_s_2016_4				
Comment Code					
S2 : Repair the levee slope damaged by foot traffic and prevent access where possible.					
Inspector Comment					
Foot path depression in the landside levee slope needs repaired. Fall 2016.

View looking downstream of landside slope erosion due to heavy foot traffic. Fall 2016.

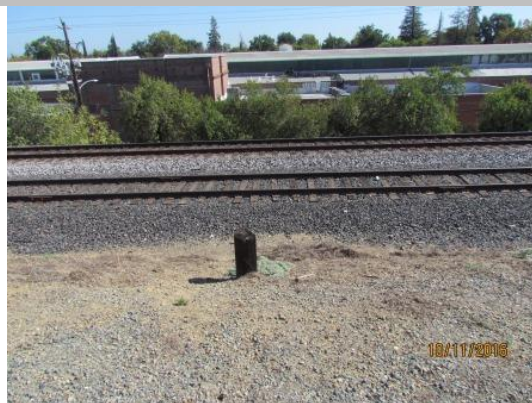
Photo 1 of 1 : FA_2016_NA0004_105_10_20161013_00012.jpg

LM Start	0.58	Rating **	M	Issue No.	10
LM End	0.58	Issue Type +	En	Location *	LS
Category	Earthen Levee			GPS Latitude/Longitude	
				Start	End
Item	Encroachments			39.141181 °	39.141181 °
				-121.600045 °	-121.600045 °
DWR ID	DWR_NA0004_02_f_2016_10				
Comment Code					
PO : Pole					
Inspector Comment					
Cut off telephone pole on the landside slope needs to be removed. Fall 2016.

View showing 2 of 4 cut off telephone pole on the landside slope. Fall 2016.

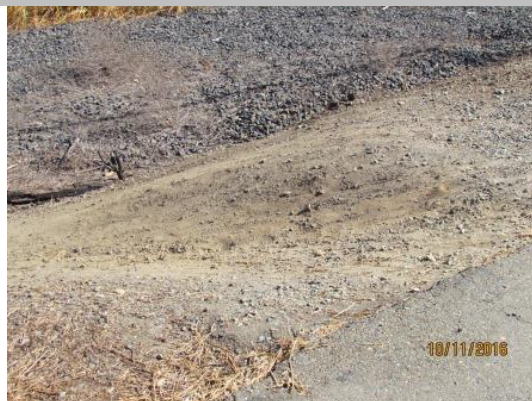
Photo 1 of 1 : FA_2016_NA0004_105_13_20161013_00017.jpg

LM Start	0.82	Rating **	M	Issue No.	13
LM End	0.82	Issue Type +	Ma	Location *	LS
Category	Earthen Levee			GPS Latitude/Longitude	
				Start	End
Item	Slope Stability			39.138827 °	39.138827 °
				-121.599530 °	-121.599530 °
DWR ID	DWR_NA0004_02_f_2016_13				
Comment Code					
S2 : Repair the levee slope damaged by foot traffic and prevent access where possible.					
Inspector Comment					
Foot path depression in the landside levee slope needs repaired. Fall 2016.

View of foot path depression in the landside levee slope. Fall 2016.

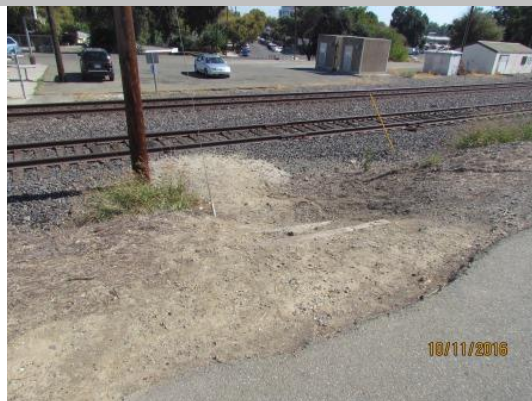
Photo 1 of 1 : FA_2016_NA0004_105_14_20161013_00018.jpg

LM Start	0.85	Rating **	M	Issue No.	14
LM End	0.85	Issue Type +	Ma	Location *	LS
Category	Earthen Levee			GPS Latitude/Longitude	
				Start	End
Item	Slope Stability			39.138463 °	39.138463 °
				-121.599168 °	-121.599168 °
DWR ID	DWR_NA0004_02_f_2016_14				
Comment Code					
S2 : Repair the levee slope damaged by foot traffic and prevent access where possible.					
Inspector Comment					
Remove steps that are cut into levee slope. Fall 2016.

View of steps for foot path in the landside levee slope. Fall 2016.

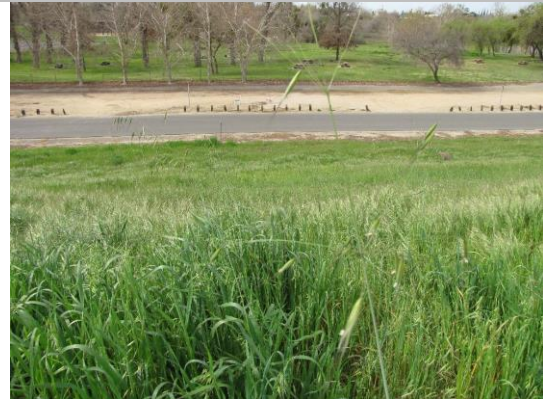
Photo 1 of 2 : UCIP_FA_2016_40940_69802.jpg

LM Start	0.87	Rating **	M	Issue No.	17
LM End	0.87	Issue Type +	En	Location *	LS
Category	Supplemental			GPS Latitude/Longitude	
				Start	End
Item	DWR UCIP Field Study			39.138269 °	39.138269 °
				-121.599004 °	-121.599004 °
DWR ID					
Comment Code					
Inspector Comment					
FS_ID:40940					
DS_ID:19123					
EP_NO: N/A					
Repair Type: Non-Urgent					
Crossing Status: Indicator Found					
UCIP Comments: Unable to tell if crossing goes through levee; according to Frank Miller crossing does not cross levee. Need to contact owner to confirm alignment.					
FIELD_STRUCT_DESC: Fiber optics communication line through levee. Marker on waterward shoulder.					
FS Date: 3/15/2013

View of waterward slope.

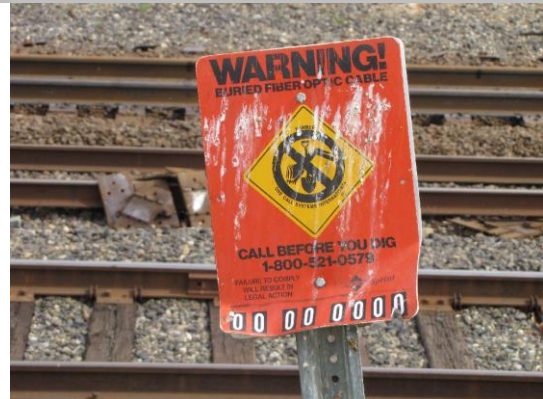
Photo 2 of 2 : UCIP_FA_2016_40940_69801.jpg

Buried fiber optical cable marker with contact information located on landward shoulder.

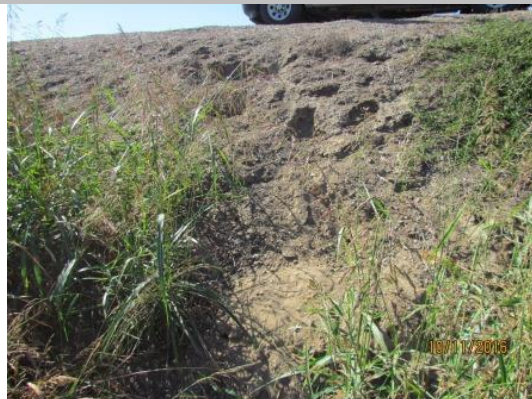
Photo 1 of 1 : FA_2016_NA0004_105_15_20161013_00019.jpg

View of squirrel holes in the landside levee slope, no sign of squirrels. Fall 2016.

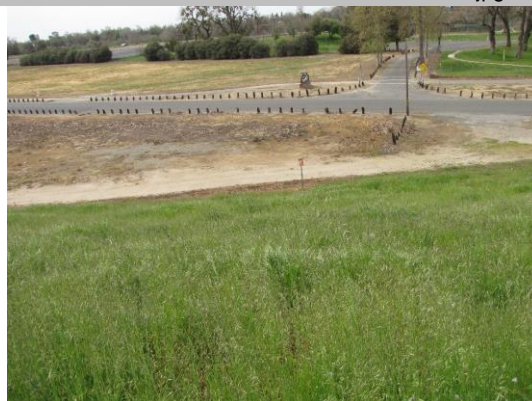
Photo 1 of 2 : UCIP_FA_2016_38272_69804.jpg

LM Start	0.91	Rating **	M	Issue No.	16
LM End	0.91	Issue Type +	En	Location *	LS
Category	Supplemental			GPS Latitude/Longitude	
				Start	End
Item	DWR UCIP Field Study			39.137749 °	39.137749 °
				-121.598560 °	-121.598560 °
DWR ID					
Comment Code					
Inspector Comment					
FS_ID:38272 DS_ID:19104 EP_NO: N/A Repair Type: Non-Urgent Crossing Status: Indicator Found UCIP Comments: Unable to tell if crossing goes through levee. Need to contact owner to confirm alignment. FIELD_STRUCT_DESC: 12-inch HDPE conduit, with electrical lines, through the levee. Extends to controller cabinet within the overflow area. FS Date: 3/15/2013

View of markers located on waterward toe.

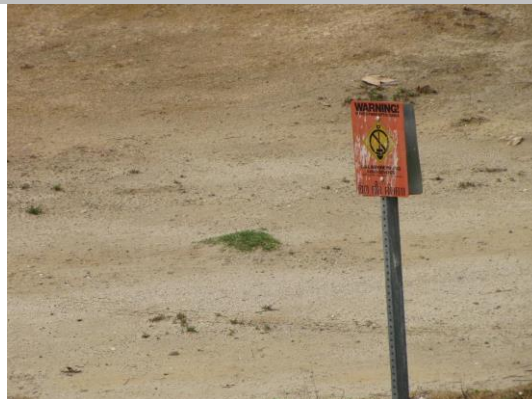
Photo 2 of 2 : UCIP_FA_2016_38272_69805.jpg

LM Start	0.91	Rating **	M	Issue No.	16 (cont)
LM End	0.91	Issue Type +	En	Location *	LS
Category	Supplemental			GPS Latitude/Longitude	
				Start	End
Item	DWR UCIP Field Study			39.137749 °	39.137749 °
				-121.598560 °	-121.598560 °
DWR ID					
Comment Code					
Inspector Comment					
FS_ID:38272					
DS_ID:19104					
EP_NO: N/A					
Repair Type: Non-Urgent					
Crossing Status: Indicator Found					
UCIP Comments: Unable to tell if crossing goes through levee. Need to contact owner to confirm alignment.					
FIELD_STRUCT_DESC: 12-inch HDPE conduit, with electrical lines, through the levee. Extends to controller cabinet within the overflow area.					
FS Date: 3/15/2013

View of markers located on waterward toe.

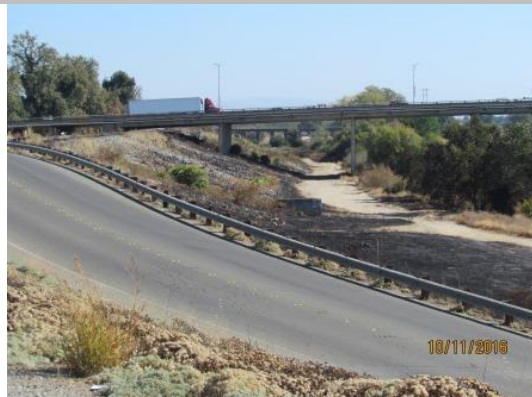
Photo 1 of 1 : FA_2016_NA0004_106_46_20161013_00055.jpg

View of the waterside looking upstream of the well maintained annual vegetation. Fall 2016.

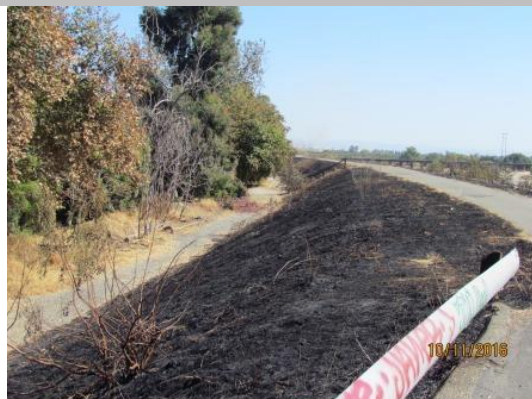
Photo 1 of 1 : FA_2016_NA0004_106_45_20161013_00056.jpg

View of the landside looking upstream of the well maintained annual vegetation. Fall 2016.

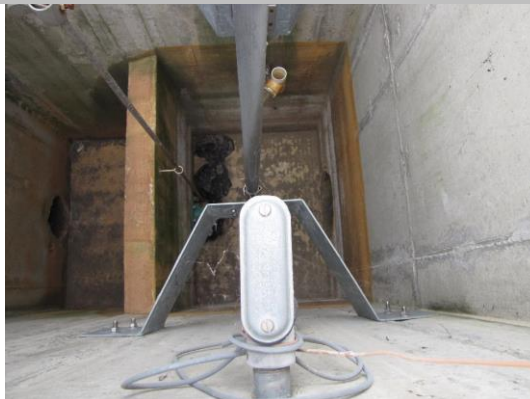
Photo 1 of 2 : UCIP_FA_2016_41024_72681.jpg

LM Start	0.04	Rating **	M	Issue No.	54
LM End	0.04	Issue Type +	En	Location *	LS
Category	Supplemental			GPS Latitude/Longitude	
				Start	End
Item	DWR UCIP Field Study			39.135010 °	39.135010 °
				-121.593225 °	-121.593225 °
DWR ID					
Comment Code					
Inspector Comment					
FS_ID:41024 DS_ID:25055 EP_NO: N/A Repair Type: Non-Urgent Crossing Status: Found UCIP Comments: Appears that crossing is currently not in use. If crossing is to be abandoned, wwner will need to contact CVFPB to coordinate about proper removal. FIELD_STRUCT_DESC: 10-inch sewer line visible on landward side. According to Marysville Treatment Plant Manager this crossing was installed in 1995-1996. Coordinates for box located on landward side: 39.135185, -121.593254. Note coordinates used for levee crossing are projected coordinates. FS Date: 3/14/2013

Inside view of concrete box.

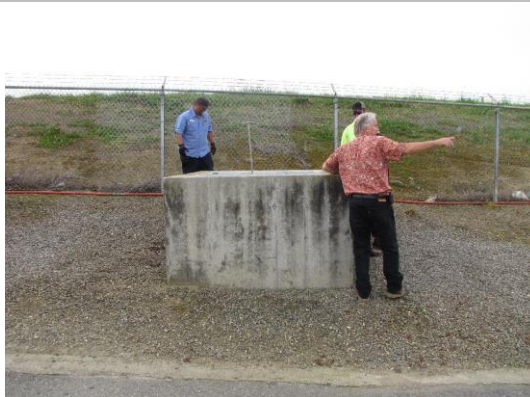
Photo 2 of 2 : UCIP_FA_2016_41024_72680.jpg

View of concrete box located on landward side--crossing not in use according to Marysville Sewage Treatment Plant Manager.

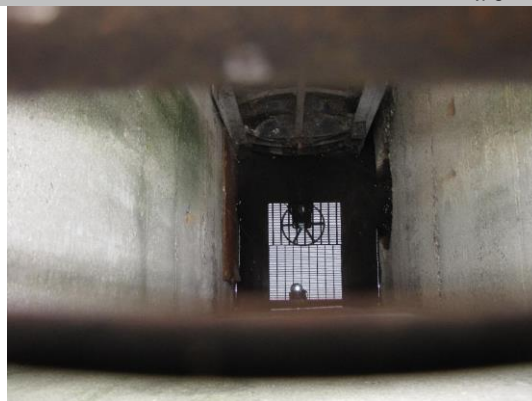
Photo 1 of 2 : UCIP_FA_2016_41025_69812.jpg

LM Start	0.07	Rating **	M	Issue No.	55
LM End	0.07	Issue Type +	En	Location *	LS
Category	Supplemental			GPS Latitude/Longitude	
				Start	End
Item	DWR UCIP Field Study			39.135090 °	39.135090 °
				-121.592663 °	-121.592663 °
DWR ID					
Comment Code					
Inspector Comment					
FS_ID:41025					
DS_ID:19126					
EP_NO: N/A					
Repair Type: Non-Urgent					
Crossing Status: Found					
UCIP Comments: Owner will need to coordinate with DWR-Inspector and CVFPB to determine if crossing meets Title 23 requirements for proper abandonment.					
FIELD_STRUCT_DESC: Abandoned 24-inch diameter outfall line through levee, under Permit No. 4714 (1963). Pipe completely grouted in levee section, cut at slopes. Coordinates for box located on landward side: 39.135259, -121.592593. Note coordinates used for levee crossing are projected coordinates.					
FS Date: 3/15/2013

Abandoned line sealed with metal plate.

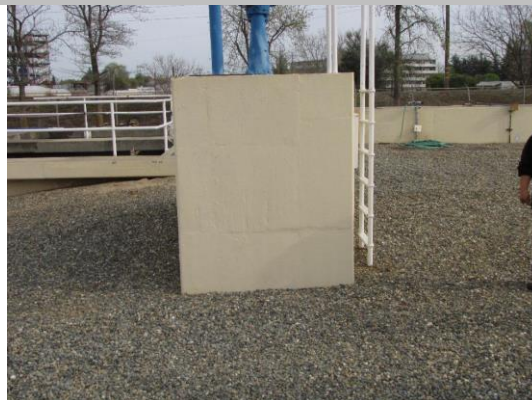
Photo 2 of 2 : UCIP_FA_2016_41025_69811.jpg

Standpipe where old line is still located.

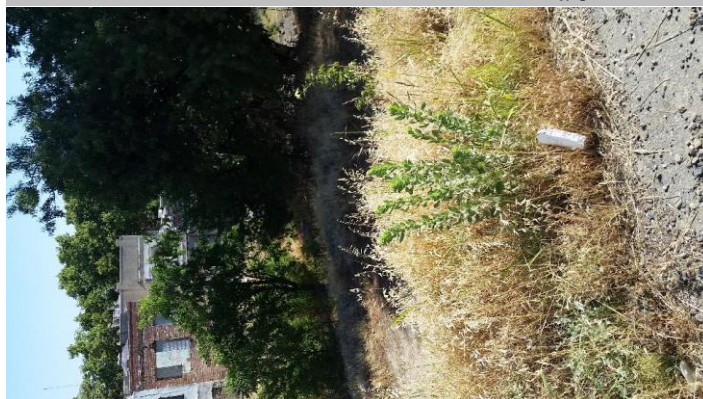
Photo 1 of 2 : UCIP_FA_2016_49942_75434.jpg

View of LS slope--no markers found.

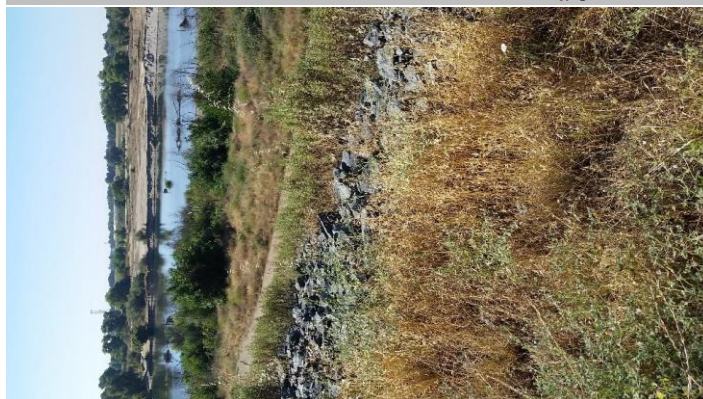
Photo 2 of 2 : UCIP_FA_2016_49942_75435.jpg

View of WS slope--no markers found.

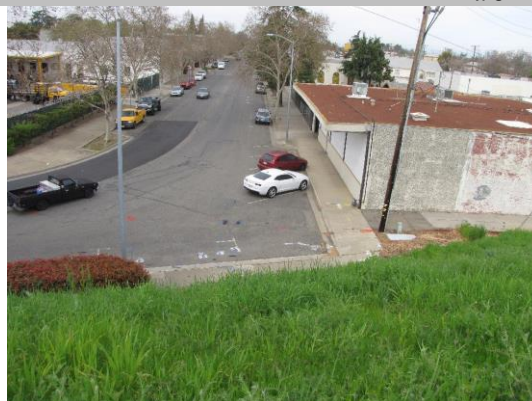
Photo 1 of 2 : UCIP_FA_2016_40969_72683.jpg

Underground service alert (USA) blue paint indicators of water line present on landward side.

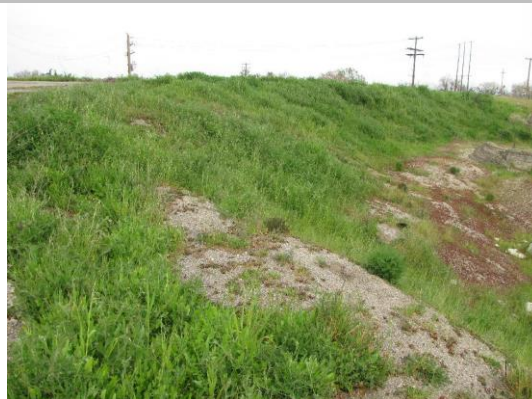
Photo 2 of 2 : UCIP_FA_2016_40969_72682.jpg

View of waterward slope--unable to confirm if crossing is active--line buried.

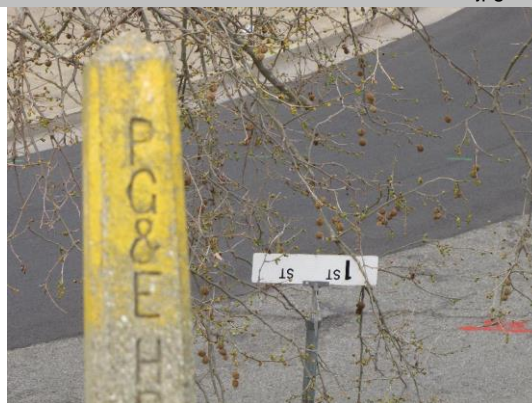
Photo 2 of 2 : UCIP_FA_2016_49944_72685.jpg

PG&E gas line

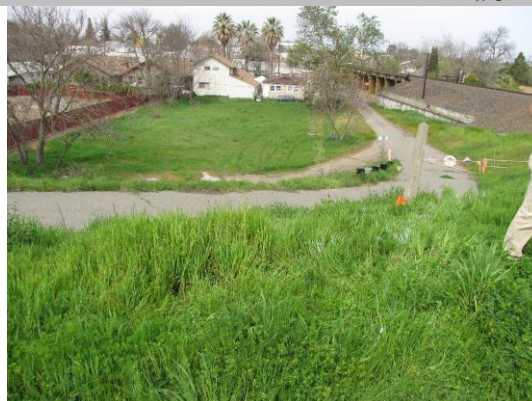
Photo 1 of 2 : UCIP_FA_2016_49945_72702.jpg

View of LS--underground alert service (USA) flags visible on LS shoulder.

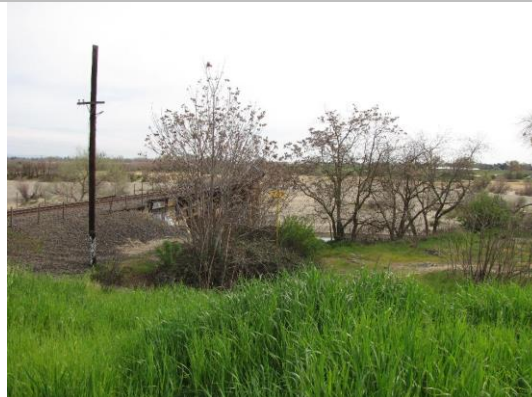
Photo 1 of 2 : UCIP_FA_2016_49947_72690.jpg

View of WS--marker visible inside channel.

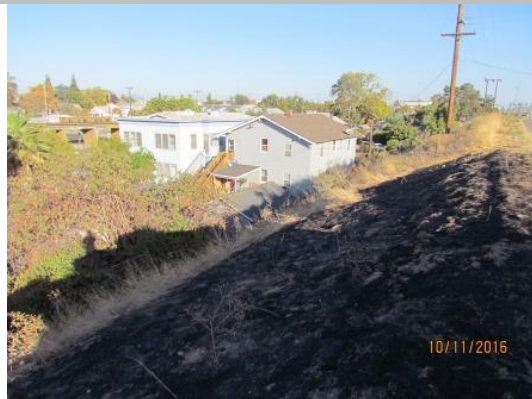
Photo 1 of 1 : FA_2016_NA0004_106_25_20161013_00059.jpg

View of House and shed at the landside levee toe looking upstream. Fall 2016.

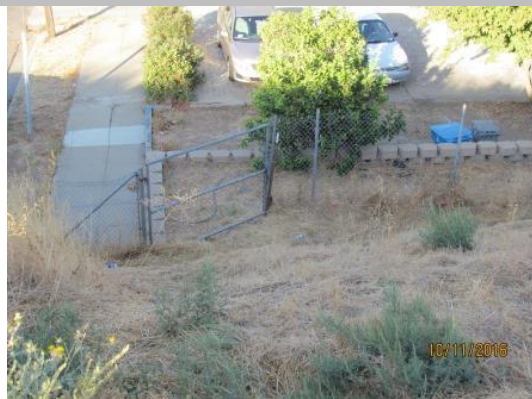
Photo 1 of 1 : FA_2016_NA0004_106_26_20161013_00060.jpg

View of fence that runs along landside levee toe. Fall 2016.

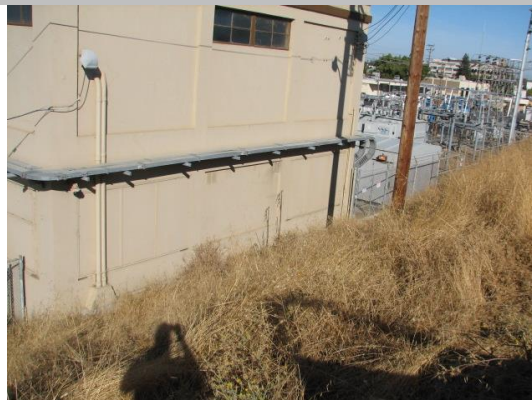
Photo 1 of 1 : FA_2016_NA0004_106_4_20160906_00002.jpg

Building encroaching at landside levee toe.

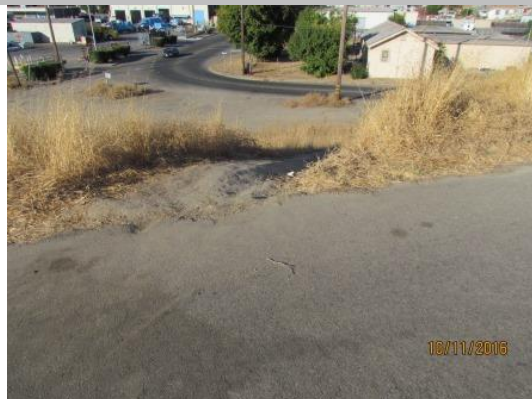
Photo 1 of 1 : FA_2016_NA0004_106_30_20161013_00061.jpg

View of path cut in by foot traffic on the landside slope. Fall 2016.

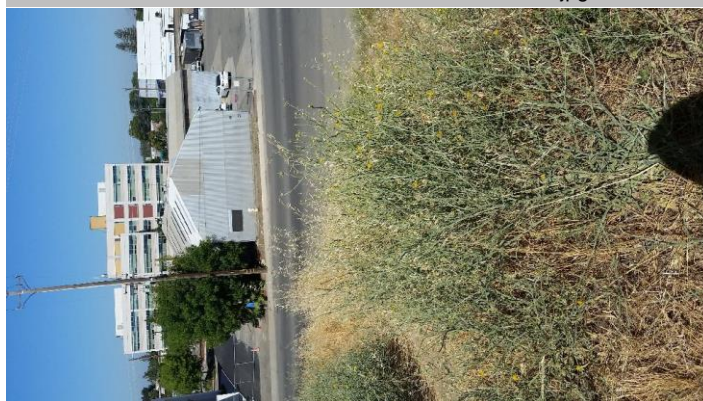
Photo 1 of 2 : UCIP_FA_2016_49949_75453.jpg

View of LS where crossing should be.

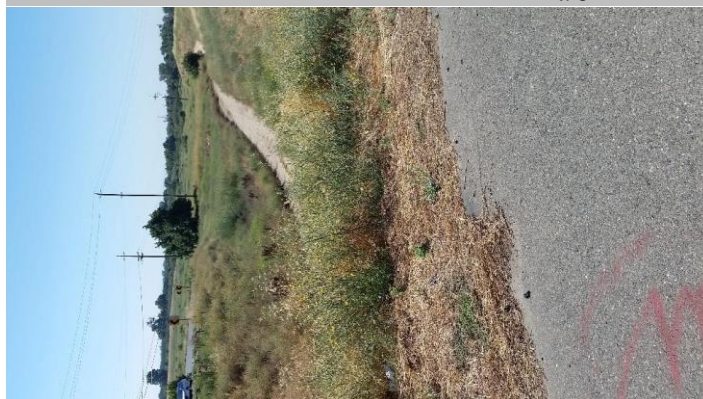
Photo 2 of 2 : UCIP_FA_2016_49949_75454.jpg

View of WS where crossing should be.

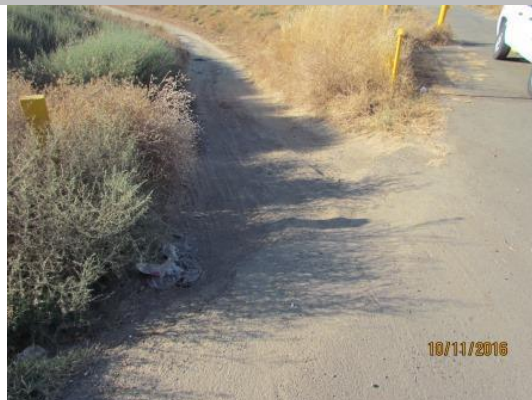
Photo 1 of 1 : FA_2016_NA0004_106_32_20161013_00062.jpg

View of ruts cut in by vehicle traffic on the waterside slope. Fall 2016.

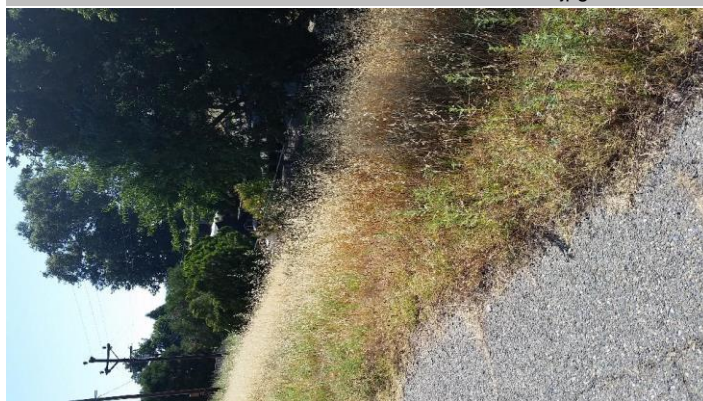
Photo 2 of 2 : UCIP_FA_2016_49951_75778.jpg

View of WS--dense vegetation on slope.

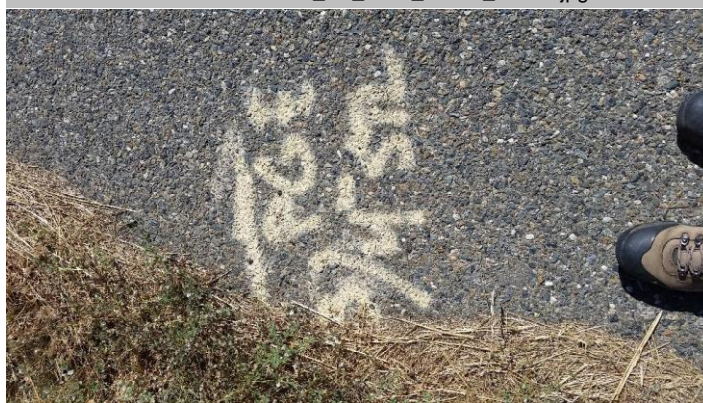
Photo 2 of 2 : UCIP_FA_2016_49952_75458.jpg

Underground Alert Service (USA) markings visible on LS hinge point.

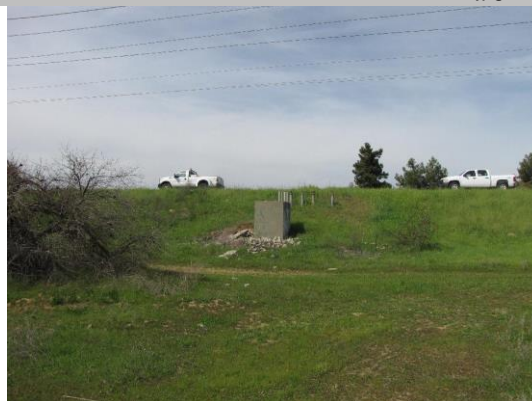
Photo 2 of 2 : UCIP_FA_2016_40999_69829.jpg

View of waterward side--concrete box and vent pipes located on waterward slope.

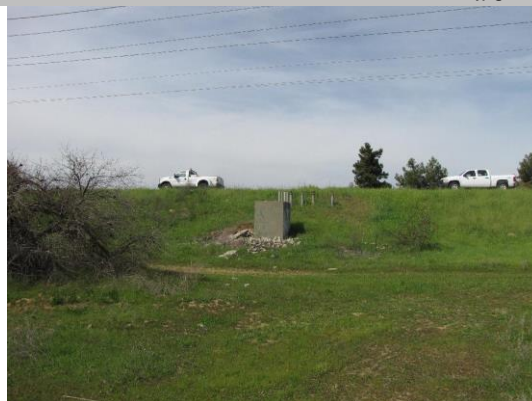
Photo 2 of 2 : UCIP_FA_2016_40998_69834.jpg

Concrete box and vent pipes located on waterward slope.

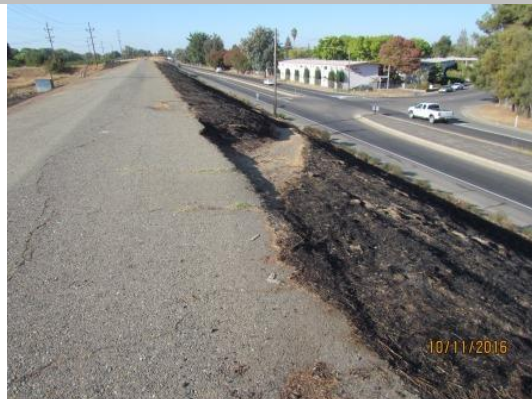
Photo 1 of 1 : FA_2016_NA0004_106_40_20161013_00081.jpg

View looking downstream of foot path that has cut into the landside levee slope. Fall 2016.

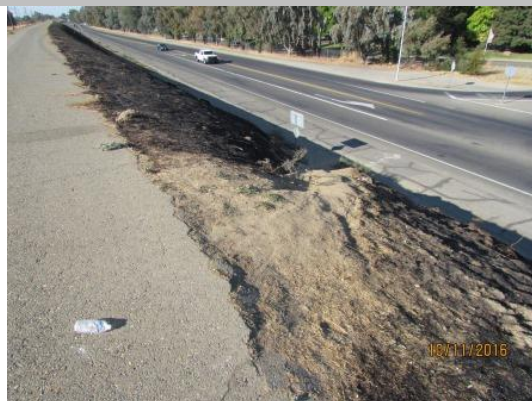
Photo 1 of 1 : FA_2016_NA0004_106_41_20161013_00080.jpg

View looking downstream of foot path that has cut into the landside slope. Fall 2016.

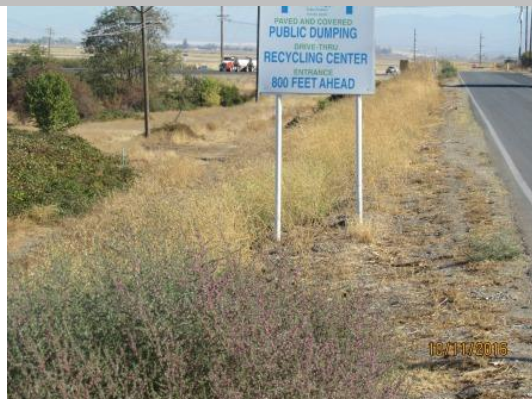
Photo 1 of 1 : FA_2016_NA0004_106_42_20161013_00074.jpg

View of vegetation on the landside slope looking upstream. Fall 2016.

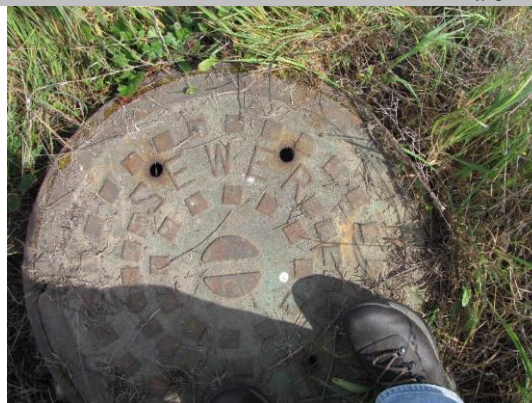
Photo 1 of 2 : UCIP_FA_2016_41002_25149.jpg

Manhole located on landward toe.

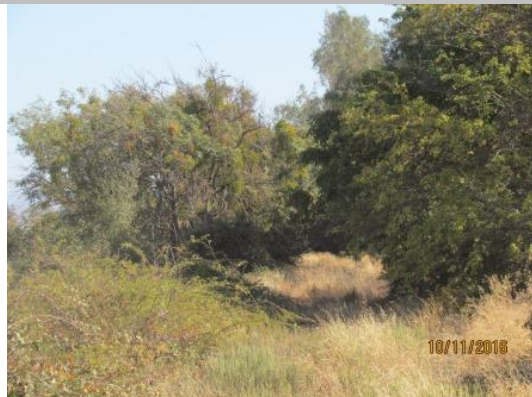
Photo 2 of 2 : FA_2016_NA0004_106_1_20161013_00076.jpg

Marysville, Unit 3 - Fall 2016 - Patrol road vegetation. This portion of levee is not maintained.

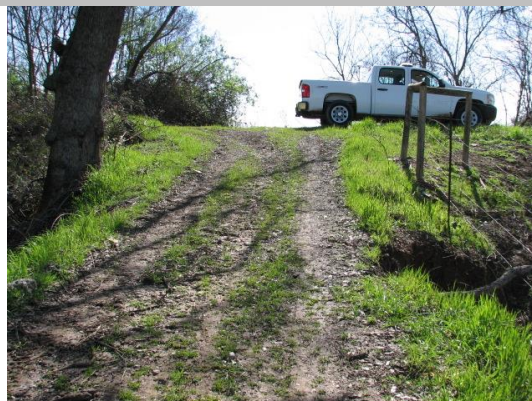
Photo 1 of 1 : FA_2016_NA0004_106_10_20160906_00005.jpg

This ramp is on the patrol road, no known permit.
